INSPECTION CONDITIONS

**5220 Mockingbird Lane
Atlanta, GA 30328**

Inspection conducted by Paul
Davidson
GAHI#345-98

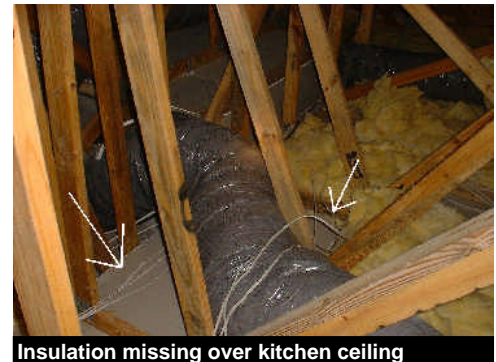
Fiberglass batts, Some insulation is installed unevenly over the kitchen area with poor general coverage. Recommend additional insulation in the attic area to improve energy efficiency.

Insulation missing over kitchen ceiling

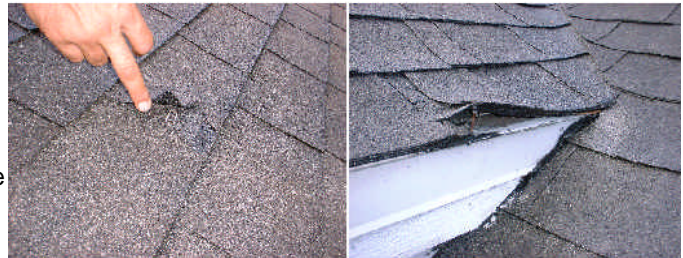
Protruding staple - Uplifted edge flashing

Fasteners are protruding from the roof surface at the rear of the roof, and flashing is uplifted and in need of repair at the front right gable. Each of these areas represents a potential area of leakage, if not now, then in the near future. [A licensed roofing contractor should be called to make further evaluation and repairs as needed.](#)

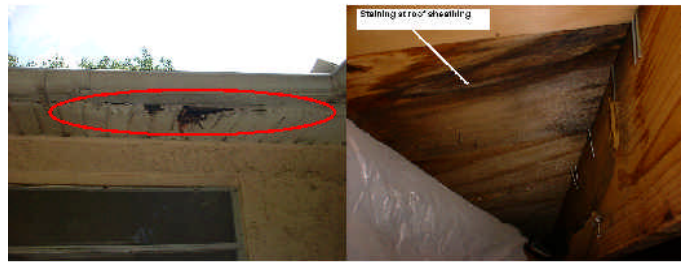
Aluminum. Damage is noted- along the overhang at the left side of the house. **Active leakage is noted within the attic area** under this portion of the roof, as shown in the 2nd photo. [A licensed roofing contractor should be called to make further evaluation and repairs as needed.](#)

Damaged Overhang/Roof Problems/Leakage

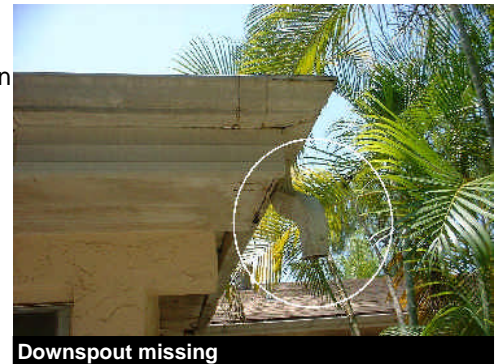
Partial, Damage/Defects viewed Gutter downspout is missing from the left rear corner of the flat porch roof. Some erosion is taking place. Replace as needed.

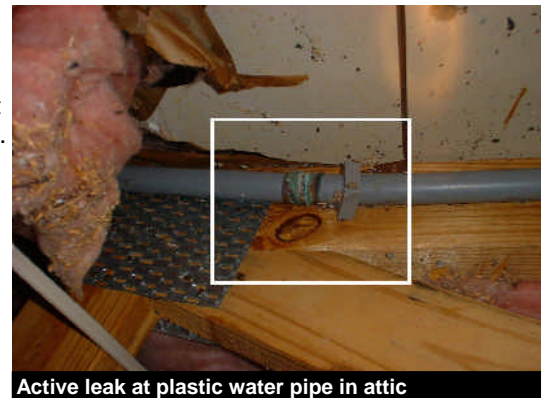
Appears serviceable, however, active leakage is noted at a crimped joint located over the family room. It's is a small drip at this time, but could result in catastrophic failure without warning. For this reason alone, repair should take place without delay. Budget \$200+

Active leak at plastic water pipe in attic

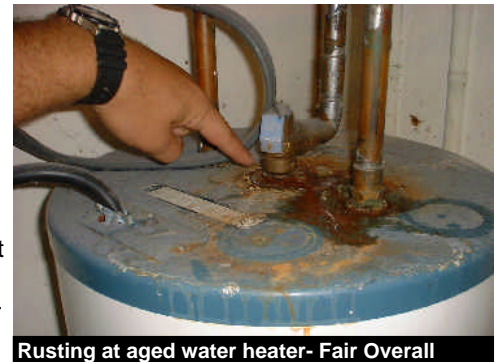
Leakage has occurred at the connected piping above the unit, causing rust to form at the top of the unit. Pressure relief valve noted, not tested, A water shutoff valve is installed but does not appear like it would work, due to rusting. No ongoing leakage is noted, but this unit now exceeds 10 years of age and will likely need replacement in the not too distant future at a cost of \$300 or so. Electric water heaters have expected service lives of 10-15 years in this area of the country.

Rusting at aged water heater- Fair Overall

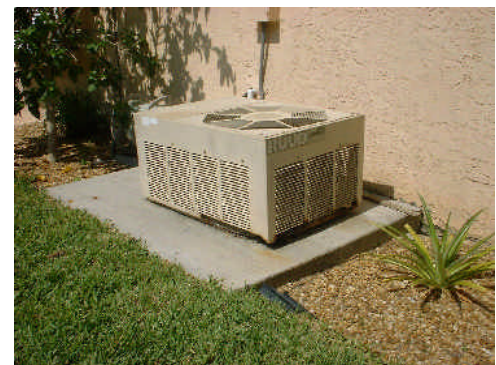
Central, Electric- The air conditioning system is completely separate from the heating system. System is operational, however, we recommend clearing foliage from unit.

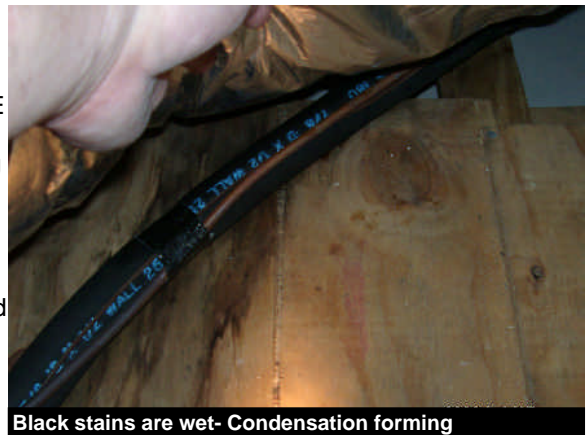
CONDENSATE LINE: Condensate line runs from the evaporator in the attic over the family room to the right exterior wall. **CONDENSATE DRAIN LINE IS SWEATING:** The condensate drain line from the air conditioning evaporator cabinet (air handler) has a tendency to sweat during hot weather, when the system is operating most of the time. Inexpensive pipe insulation should be added to the first 5 feet of this line to alleviate this condition, which if left unattended, can cause damage to ceilings. Uninsulated portions of refrigerant suction lines also can result in condensation formation and subsequent dripping and damage to attic ceilings. The remedy is the same, with addition of foam pipe insulation to remedy the problem. At this point, you may want to call a contractor who can offer a warranty on their work to make repairs.

Black stains are wet- Condensation forming

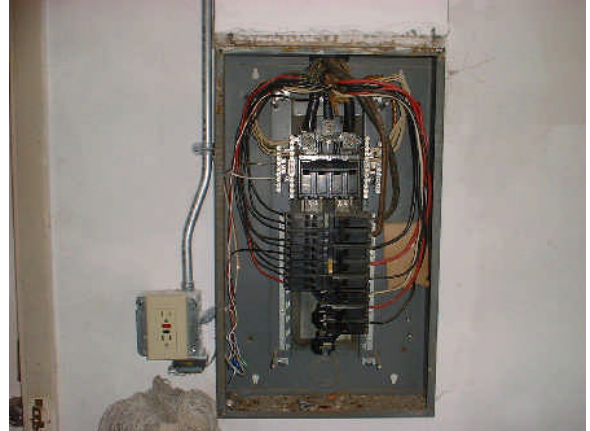
Circuit and wire sizing correct so far as visible, Grounding system is present, but loose clamp at water line or ground rod. Tighten as needed. Unused openings in the panel are missing covers, Panels are without the benefit of complete labeling.

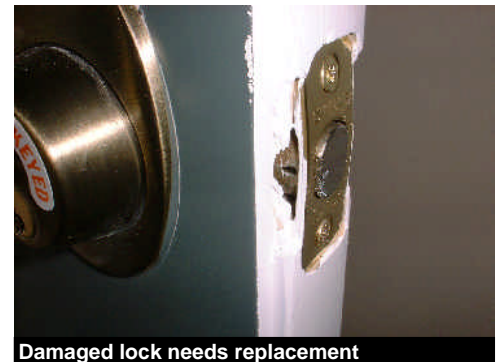
Appears serviceable, Dead Bolt is not operational, due to damage. Replace as needed.

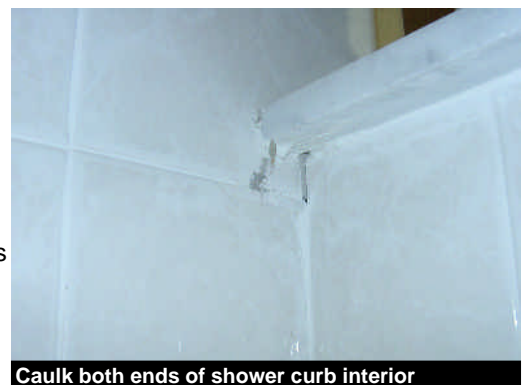
Tub and shower areas appear serviceable. Cosmetic moisture damage is noted at the wall or floor outside the tub/shower area. Caulking and/or re-grouting is needed to prevent water intrusion. Enclosure appears serviceable, but open gaps are seen under the interior of the shower curb. Caulk and seal all tub and shower areas as a precaution.

Caulk both ends of shower curb interior

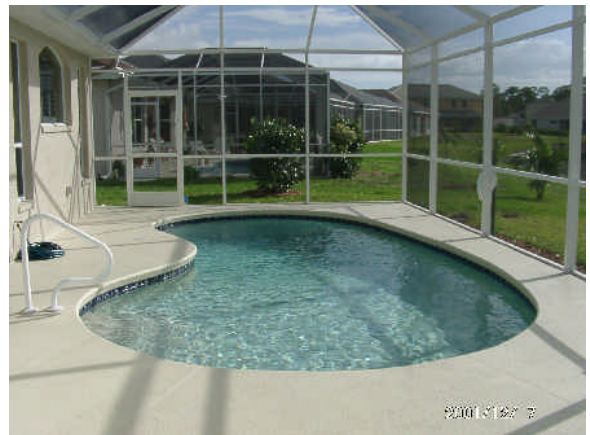
CONDITION: Appears Serviceable, The following was seen: Scale buildup at pool walls is due to excessive calcium in the pool water. Have adjustments made as needed by your pool service company. Mildly discolored surface will need an acid wash in 1-2 years. A few minor stains noted at the surface may or may not be removable.

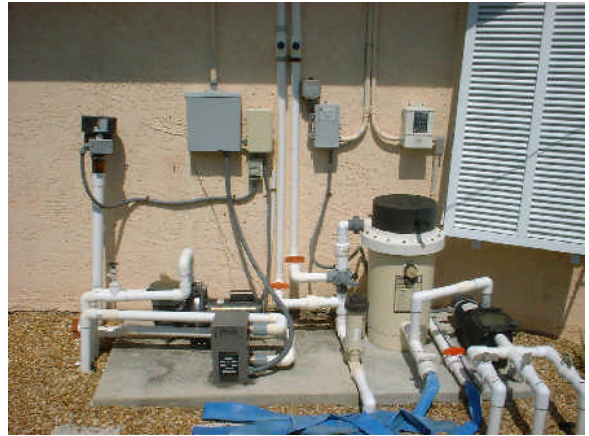
Minor leakage is noted: O-ring at the top of the filter is leaking. Minor leakage occurring at the pressure gauge. Minor leakage is seen where the return pipe is attached at the top of the pump. This is a commonly seen leak. Make minor repairs when time permits.
