INSPECTION CONDITIONS

**5220 Mockingbird Lane
Atlanta, GA 30328**

Inspection conducted by Paul
Davidson
GAHI#345-98

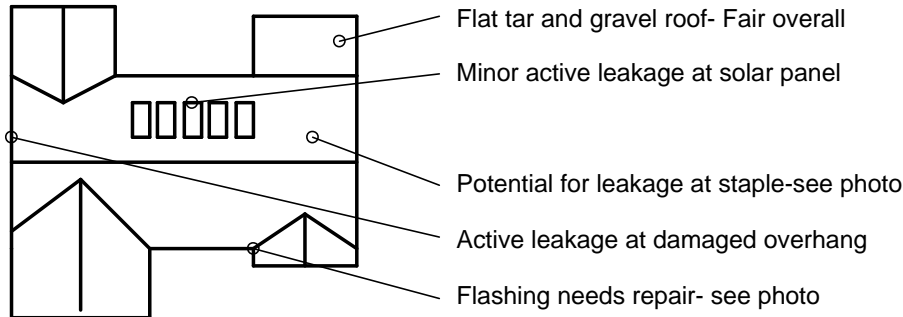
PLAN VIEW OF ROOF (not to scale)

Fasteners are protruding from the roof surface at the rear of the roof, and flashing is uplifted and in need of repair at the front right gable. Each of these areas represents a potential area of leakage, if not now, then in the near future. [A licensed roofing contractor should be called to make further evaluation and repairs as needed.](#)

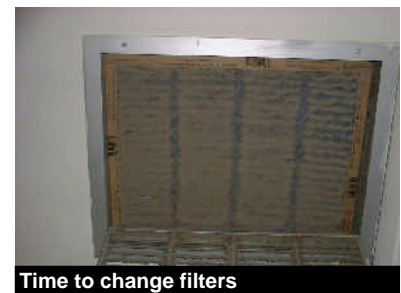
Appears serviceable.

Appear serviceable, but thermostat has a crooked mounting. Remount as desired.

Suggest cleaning/changing filter.
